AIRCRAFT ACCIDENT REPORT

TRANS WORLD AIRLINES, INC.
BOEING 707-131B, N757TW

LOS ANGELES INTERNATIONAL AIRPORT
LOS ANGELES, CALIFORNIA

REPORT NUMBER: NTSB-AAR-74-10

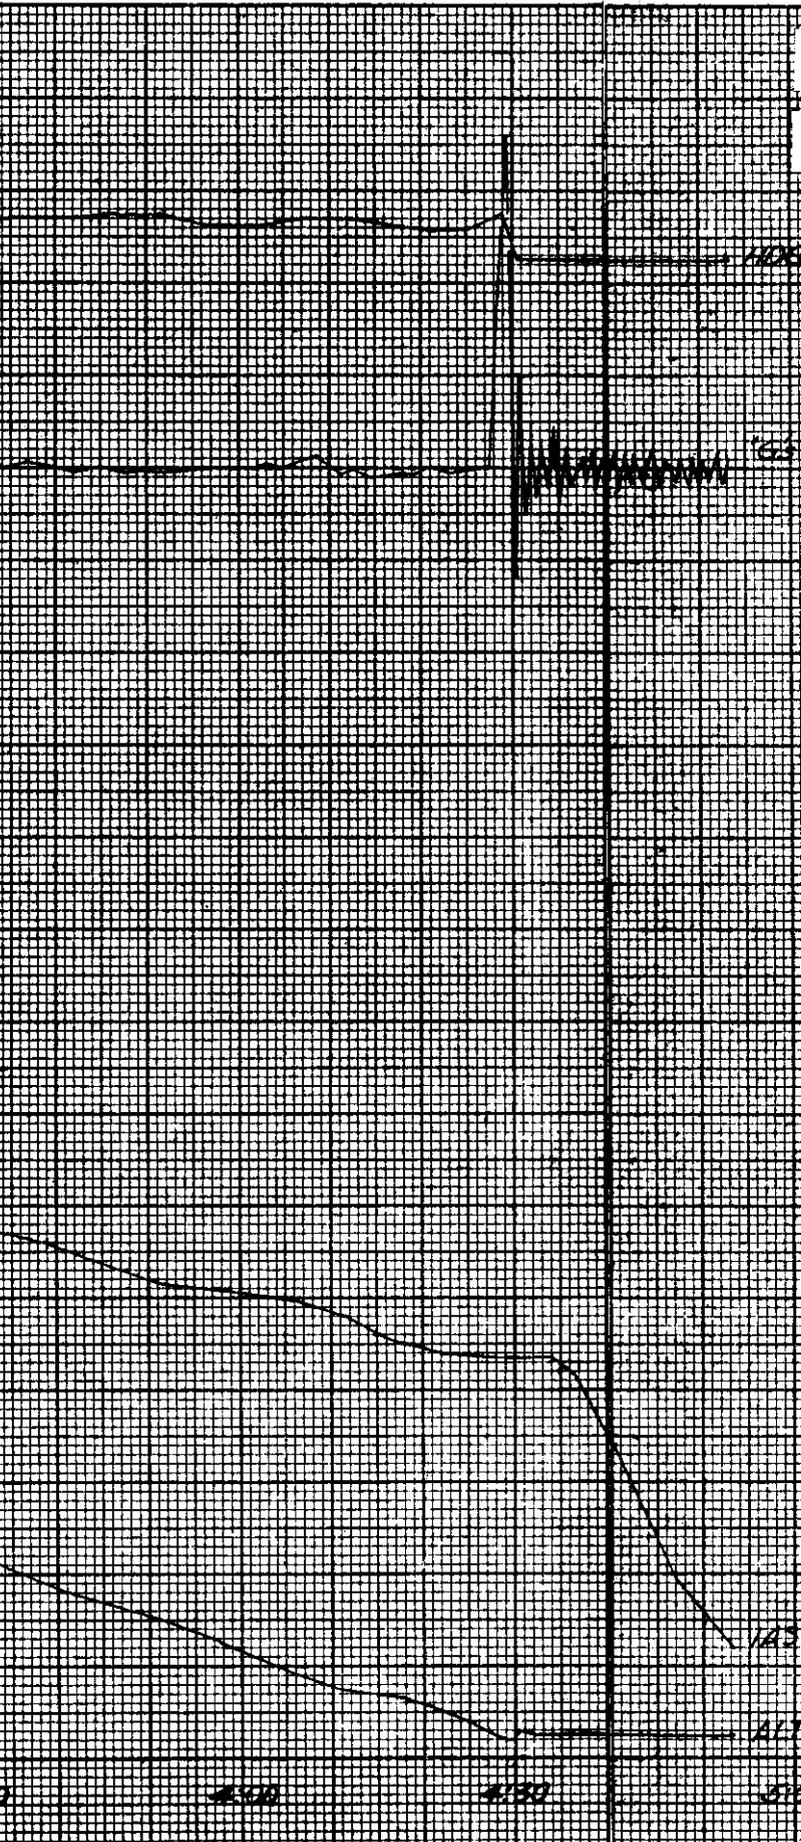
APPENDIX D

NATIONAL TRANSPORTATION SAFETY BOARD
 BUREAU OF AVIATION SAFETY
 WASHINGTON, D. C.
 TWA CRASHING NORTH OF WASHINGTON FLIGHT TO
 LOS ANGELES CONTAINING PASSENGERS & CREW
 LEAVING DELICENT
 FLIGHT DATA RECORDER'S CORNER
 CAS MODEL 702 C - SIMTEL (FORM)
